LP201 - Bug #812

D/O 12V

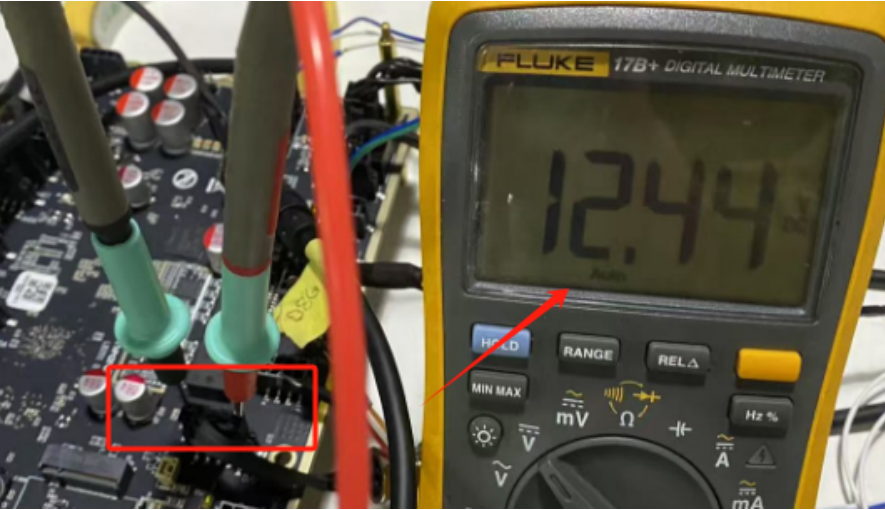
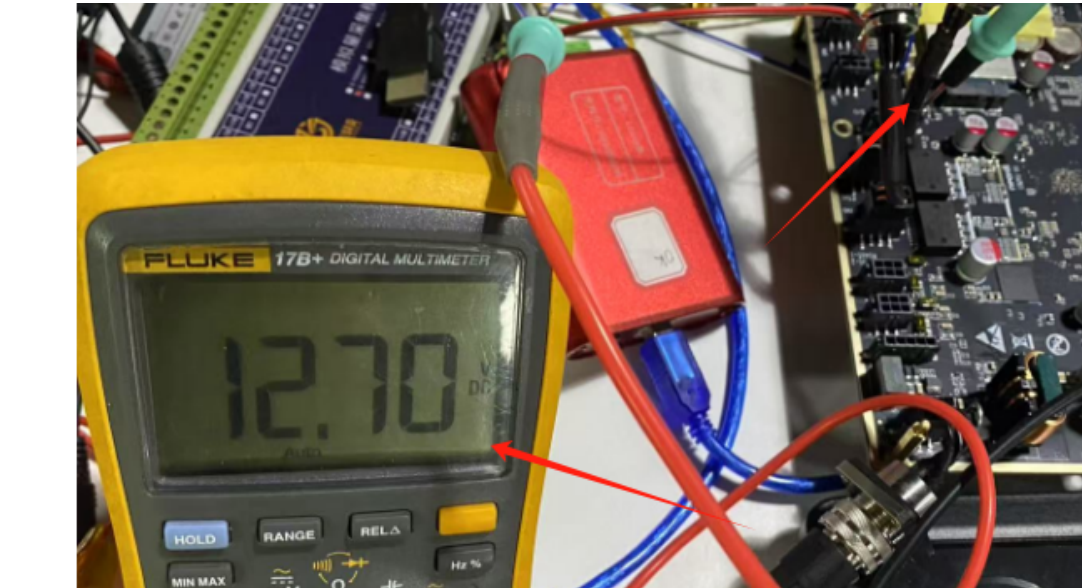
12.45v  
12.7v
