LP201 - Bug #813

GPIO55

| CPU: | RK3576 | Kernel: | v6.1.84 |
| Board: | LPS3576 | APP: | - |

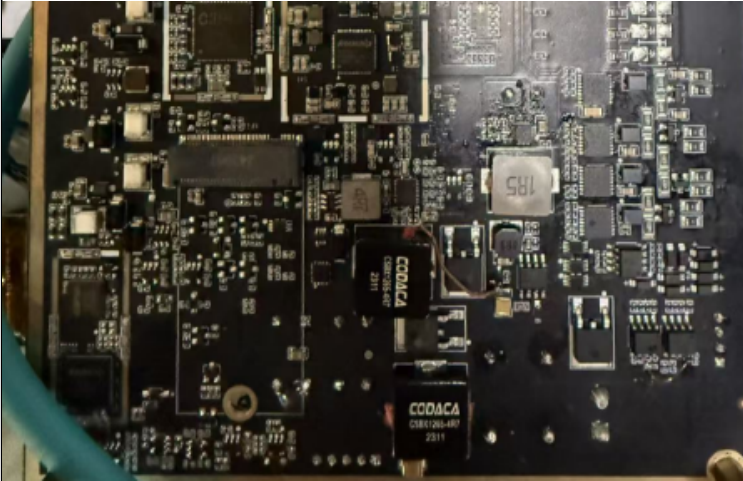
```
root@LB3576:/home/neardi/Desktop# ./gpio_test1.sh 54 13 69 19 out 1
54 out 1
13 out 1
69 out 1
19 out 1
root@LB3576:/home/neardi/Desktop# ./gpio_test1.sh 51 7 55 68 in
51 0
7 0
55 0
68 0
root@LB3576:/home/neardi/Desktop# ./gpio_test1.sh 54 13 69 19 out 0
54 out 0
13 out 0
69 out 0
19 out 0
root@LB3576:/home/neardi/Desktop# ./gpio_test1.sh 51 7 55 68 in
51 1
7 1
55 0
68 1
```
